Evaluating the Irrigation Efficiency using Rapid Appraisal Process Technique (RAP) in a Large Scale Irrigation, Case Study: Mae Lao Operation and Maintenance Project and Chiang Rai Irrigation Project, Thailand

Wongtragoon, U., Traisup, K. and Suwanmaneepong, S. (2017). Evaluating the Irrigation Efficiency Using Rapid Appraisal Process Technique (RAP) in a Large Scale Irrigation, Case Study: Mae Lao Operation and Maintenance Project and Chiang Rai Irrigation Project, Thailand. *International Journal of Agricultural Technology* 13(7.2): 2161-2174.

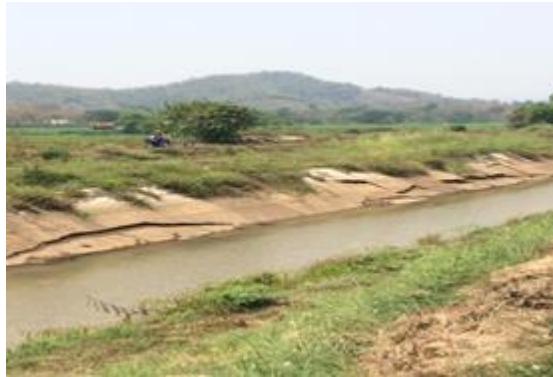
Figure 4. Broken right main canal of the Mae Lao operation and maintenance project
